# Electric Transmission Overhead Steel Structure Strategy Overview

Transmission Overhead Steel Structure Strategy - 2017

## STRUCTURES

**Prepared by: Quanta Technology  
May 2010**

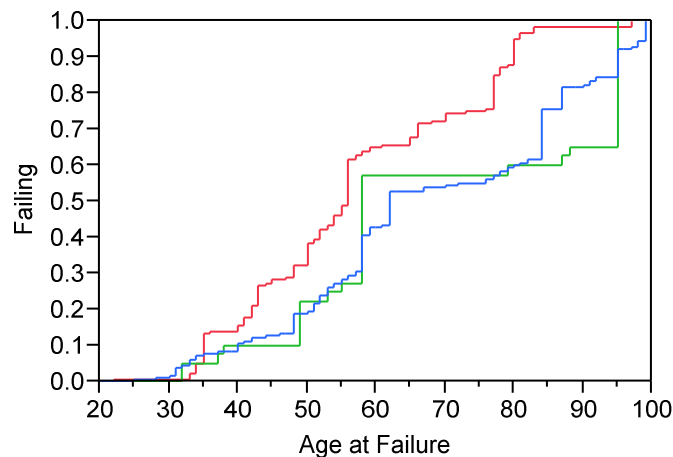
**Figure 10-10. The Kaplan Meier plots of structures in different locations**

Even though only 40 records of structure failure in the mountain region are suitable for this particular regional analysis, the failure age of structures in the mountain region spreads out basically the same age range as the other two regions, the representativeness of results for the mountain area structure can be considered as sufficient regardless its limited historical data.

The Kaplan Meier plots for structures of different types are shown in Figure 10-10.

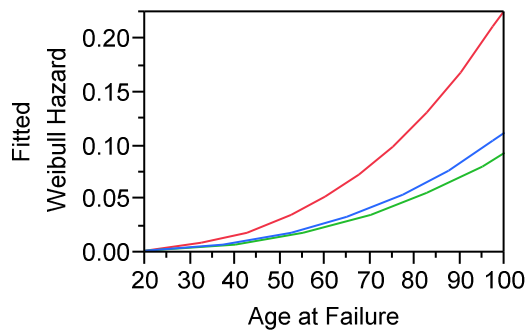
**Figure 10-12. Fitted Weibull hazard function for structures in different locations.**

As shown in Figure 10-12, the failure rate of structures in the coastal region is significantly higher than the failure rates of structures in the valley and mountain regions, with a rough ratio of 2:1. The structure failure rates in the valley and mountain regions are similar until the age of around 55; and then the failure rate of structures in the valley region are slightly higher than that of structures in the mountain region.

Structures in the Coastal region experienced failures earlier in life (peaking before 60) than in the other two regions and also had about twice the failure rate at all ages. The ages of failures for the Valley and Mountain regions (peaking around 70) as well as their failure rates were fairly similar to each other.
